Historic England

# Historic Fibrous Plaster in the UK

Guidance on its Care and Management

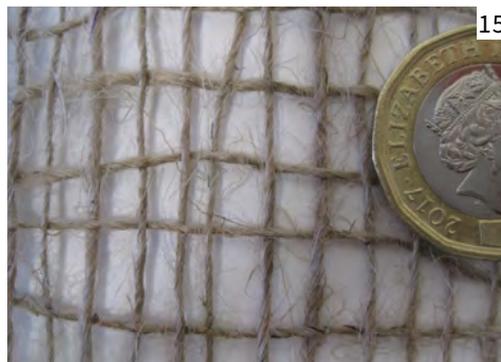
Figure 15: Modern hessian for producing traditional fibrous plaster, with a loose plain-woven fabric of twisted jute or hemp yarns. Plaster of Paris easily penetrates the widely spaced weave.

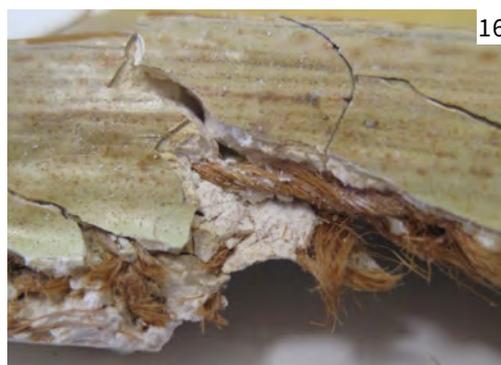
Figure 16: Section through historic fibrous plaster.

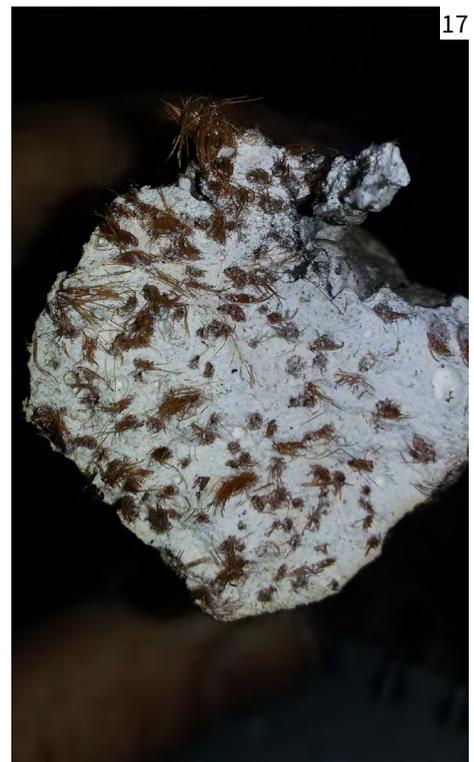
Figure 17: Section through a typical fibrous plaster wad, without wire reinforcement.

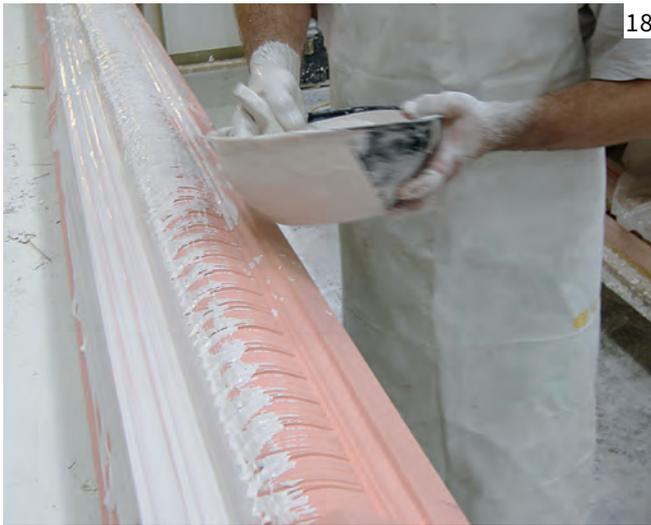
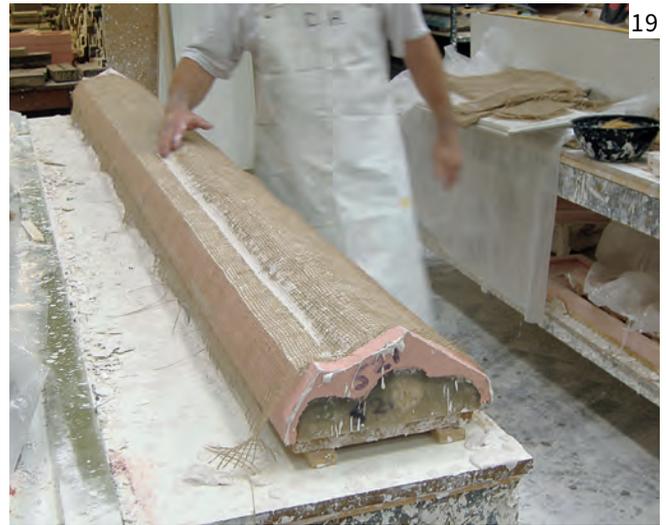
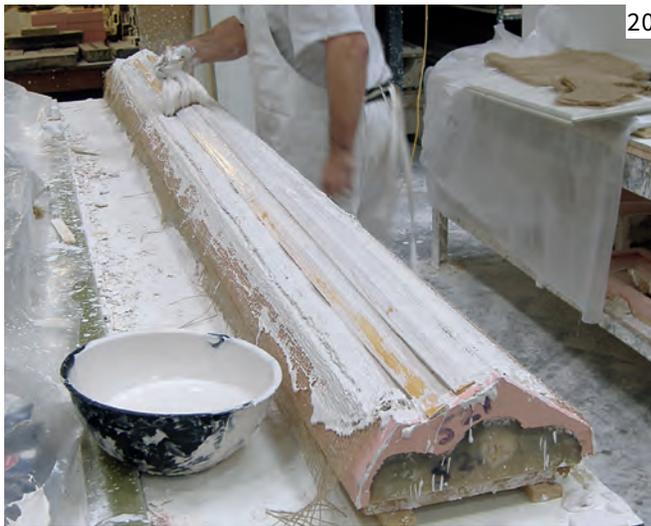
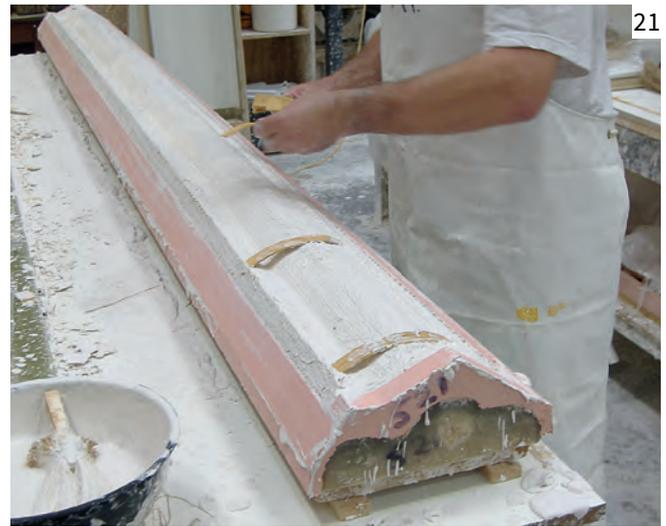
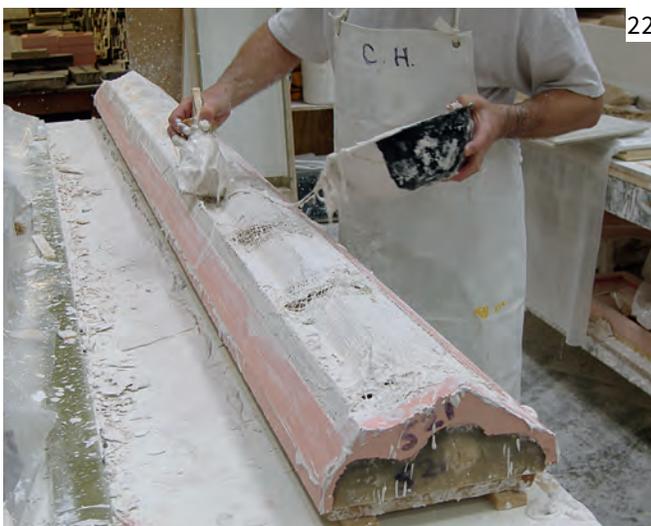
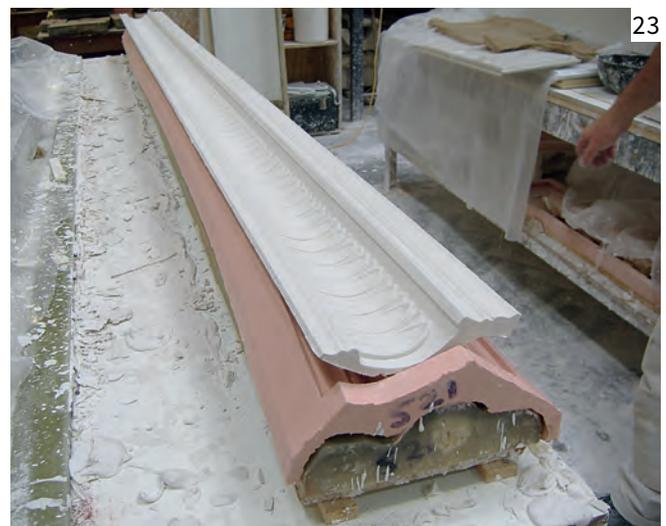
Modern production of traditional fibrous plasterwork moulding, which is slightly different from panel production

18: Brushing on plaster of Paris over a silicon rubber reverse mould.

22: Application of the final coat of plaster.

23: The hardened fibrous plaster cast after removal from the mould.

To make the cast, plaster of Paris is brushed over the mould to form the first coat ('firstings'). This is followed by another coat of plaster ('seconds') gauged with size (animal glue). The first layer of hessian is pressed into the plaster. A second layer of hessian is then laid with more seconds plaster. Timber laths are laid into the seconds plaster as reinforcement and then sealed with more hessian and plaster. The size of the fibrous plaster cast is generally limited to the reach of the plasterer's arm: approximately 2m x 2m for general handling, and safe access to the back of the cast for the installation of fixings.

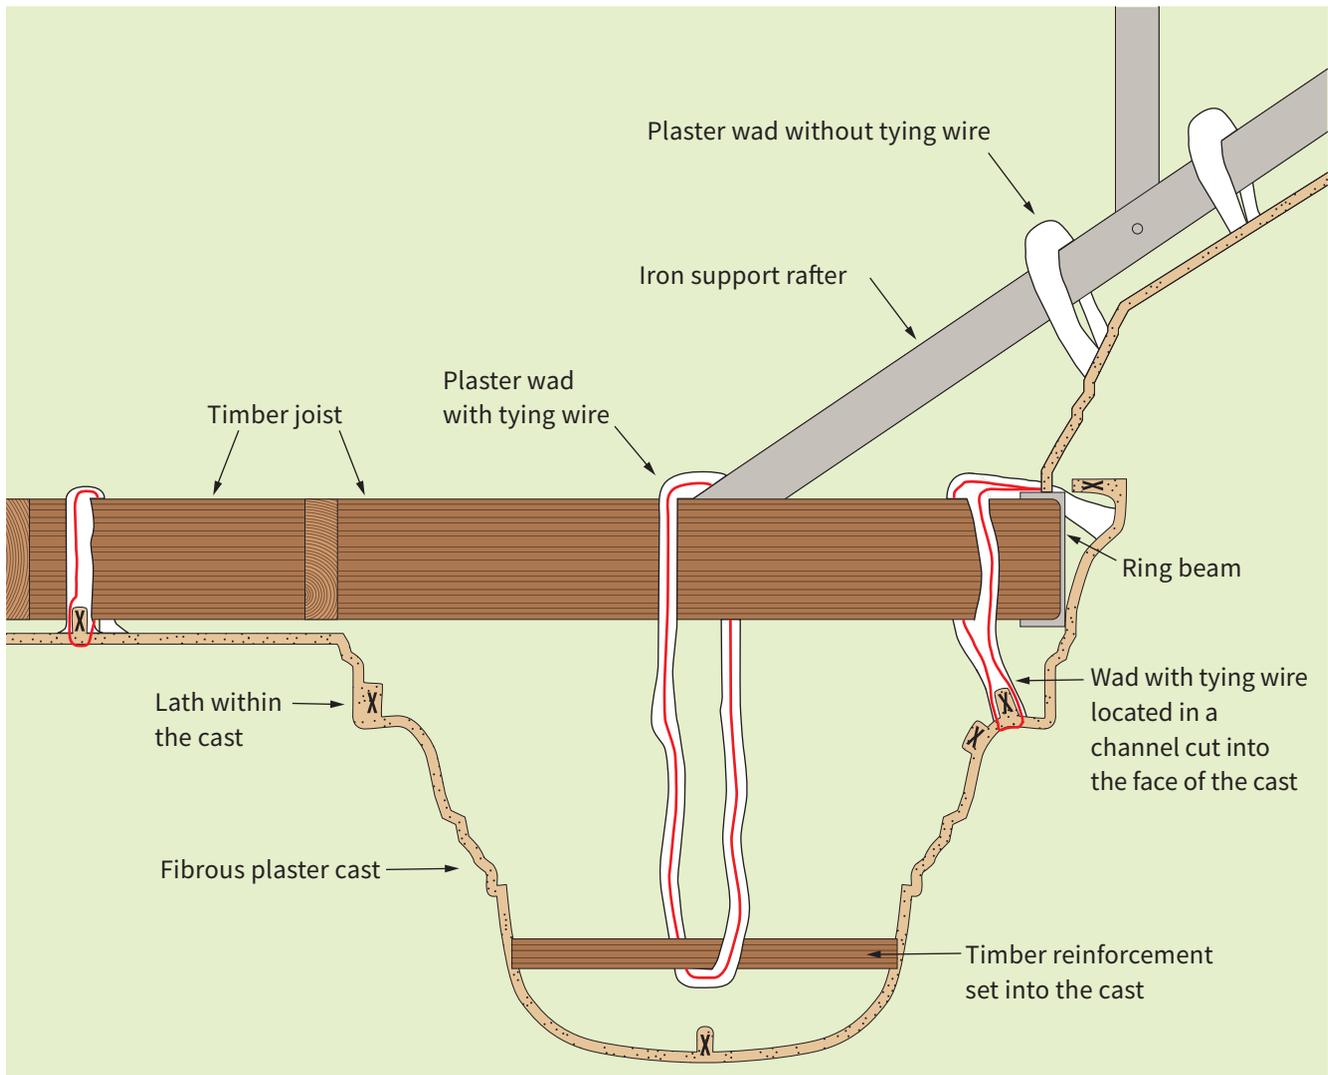
Figure 25: Section through a fibrous plaster ceiling showing wads connecting it to structural elements above. The nature of such construction can vary widely. In this example, some wads have wires tied to the underside of the cast. Other wads, without wire, are simply fixed to the cast by means of plaster within the wad.

When installed below roofs (within the area called the 'ceiling void'), fibrous plaster panels were suspended from the roof structure by means of an intermediary network of iron rods or timber battens. Fibrous panels were fixed to this network by means of wads (also known as wadding) made of hessian encased in plaster. When all plaster casts were in place each one would be wadded into the correct position, and then further support wads were incorporated. All joints to the back and face of adjacent plaster casts were made good with plaster of Paris and hessian reinforcement.

Galvanised wires were sometimes included in the wads as well. These needed to be of sufficient strength and quality, with suitable load-bearing strength, to support the fibrous plasterwork safely. However, in early fibrous plasterwork wire reinforcement of wads was not common.

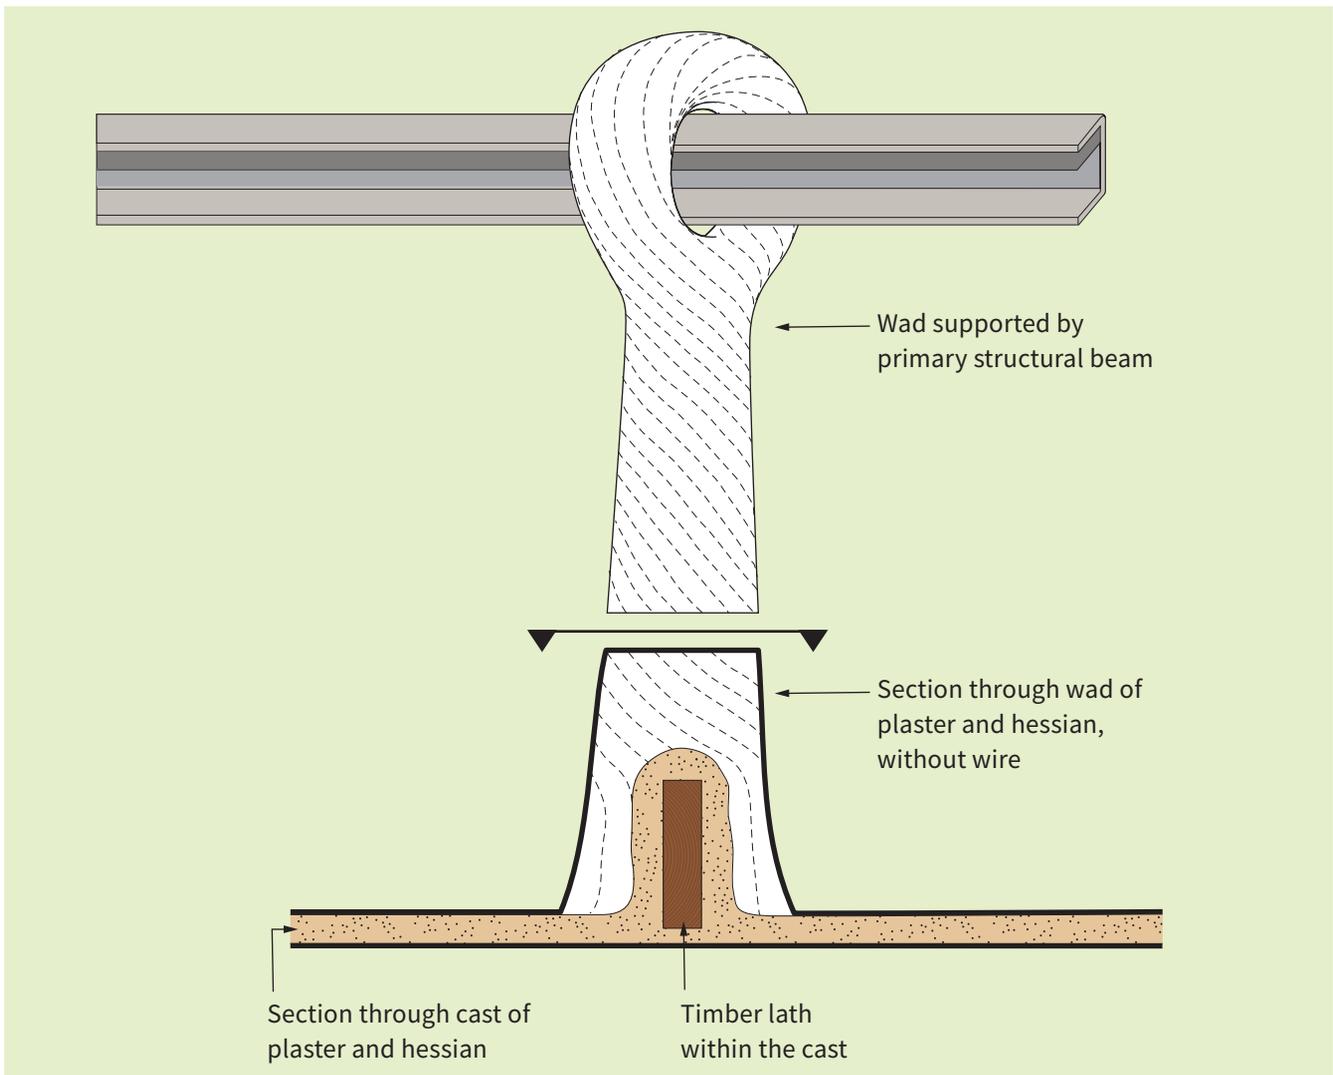
Figure 26: Section through a wad of plaster and hessian, without wire reinforcement. The adhesion between the cast and the wad is only by means of plaster-upon-plaster contact, with the fresh plaster of the wad fixed to the hardened plaster of the cast.

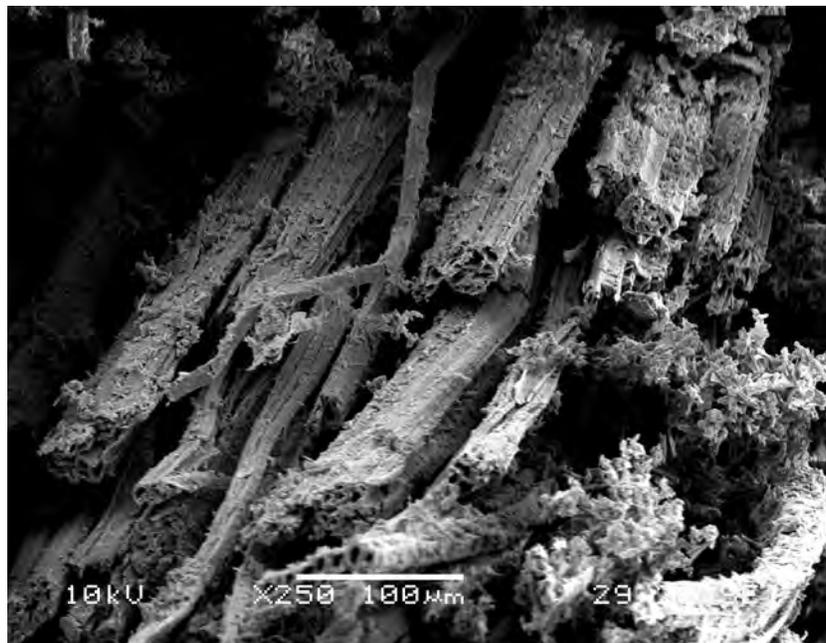
Figure 28: Scanning electron microscope image of hessian fibre bundles emerging from fractured fibrous plaster, showing clusters of ultimate fibres in each fibre bundle (x250). Analysis of the role of hessian in degradation is key to understanding fibrous plaster.

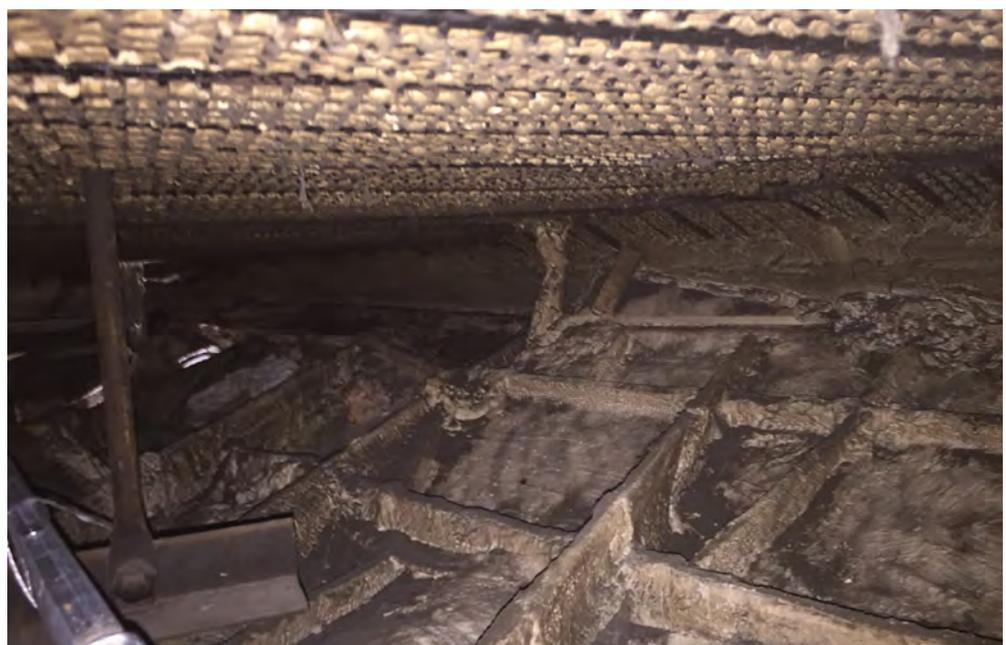
Figure 29: Large area of ceiling installed without sufficient wad connections to the panels. This can be easily detected in an inspection and remedied in subsequent repairs.

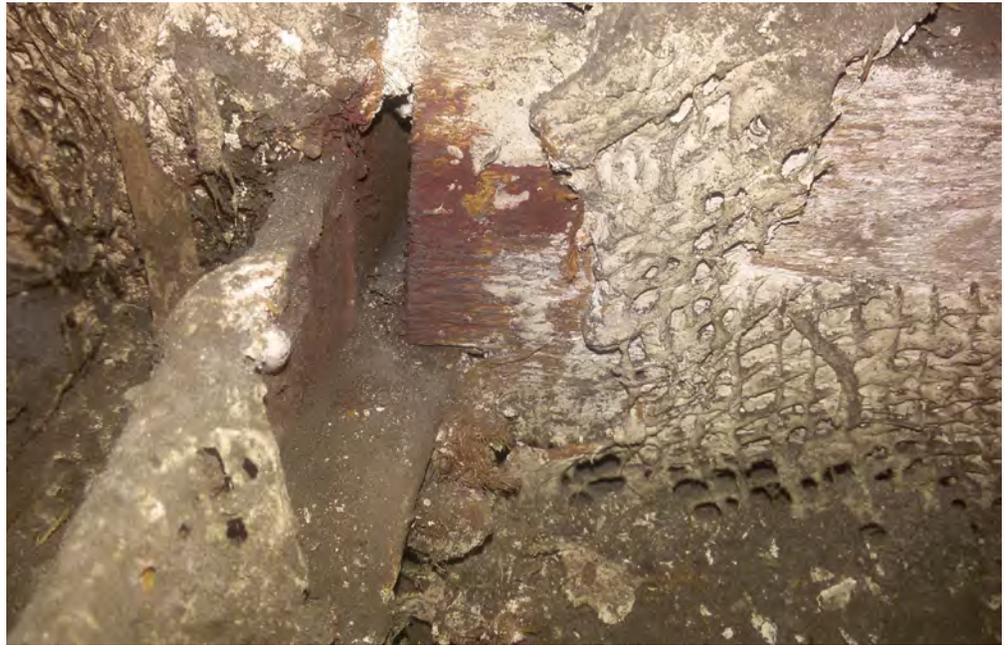
Figure 30: Poor bearing of a timber ceiling joist on a small steel T bar. The hessian has insufficient plaster cover to protect it from degradation. This illustrates how defects can be concentrated.

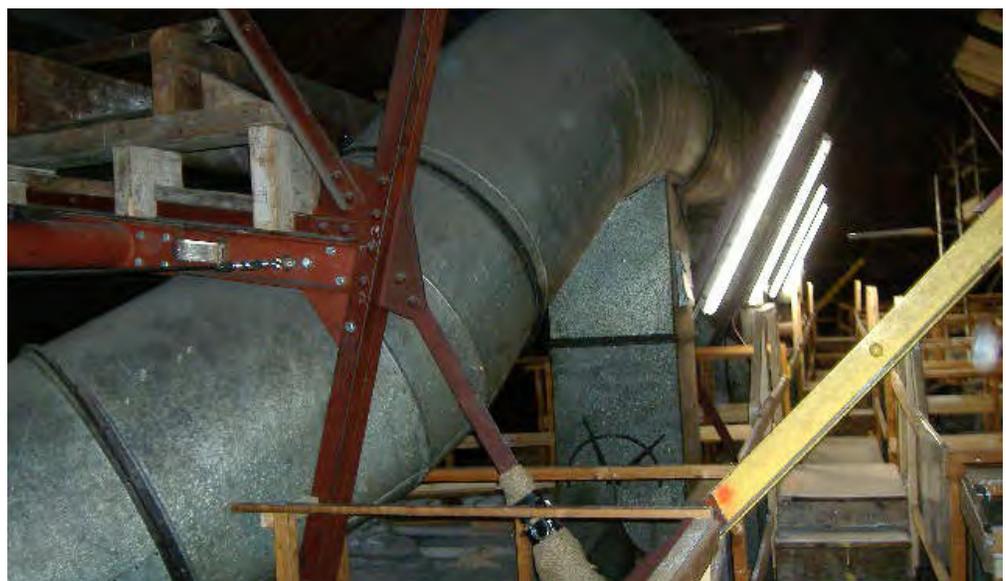
Figure 31: In ceiling voids bulky mechanical plant and boarded walkways (lower right) obscure the fibrous plaster ceiling below and impede its inspection.

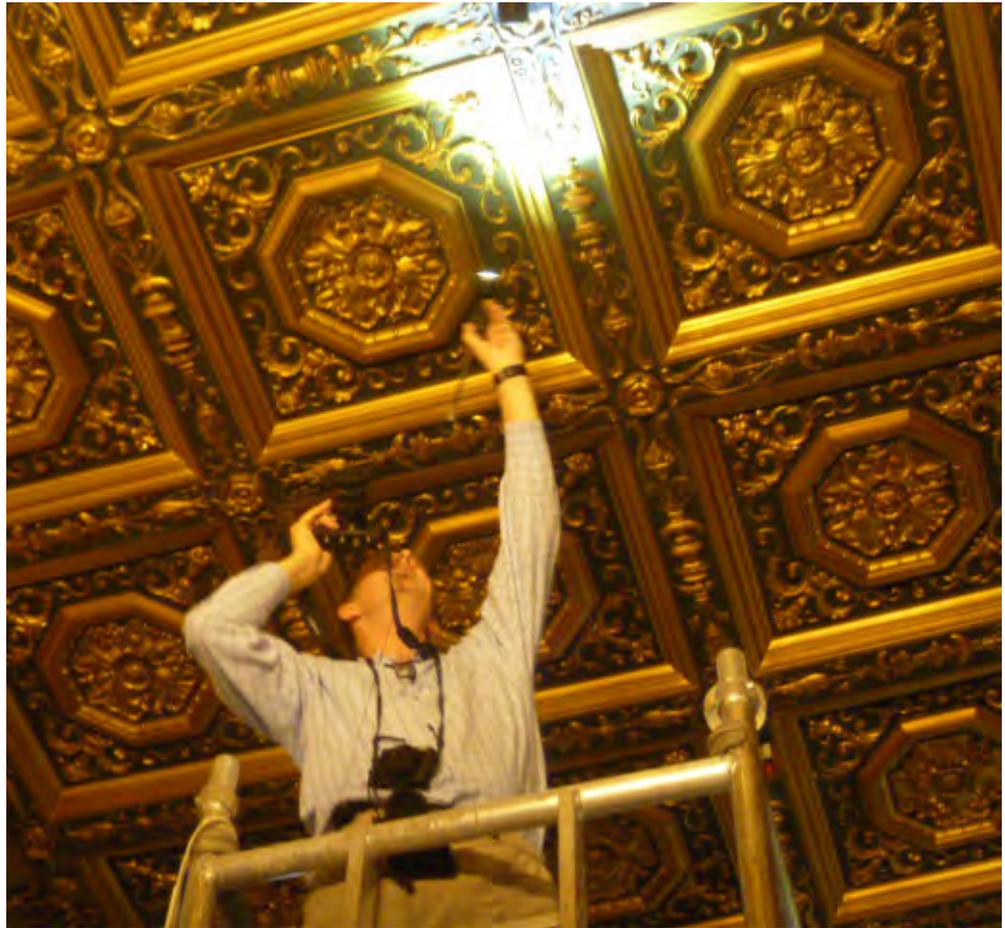
Figure 32: A tower scaffold is the most flexible means of access to inspect the underside of a ceiling, in a room with a clear, flat floor.

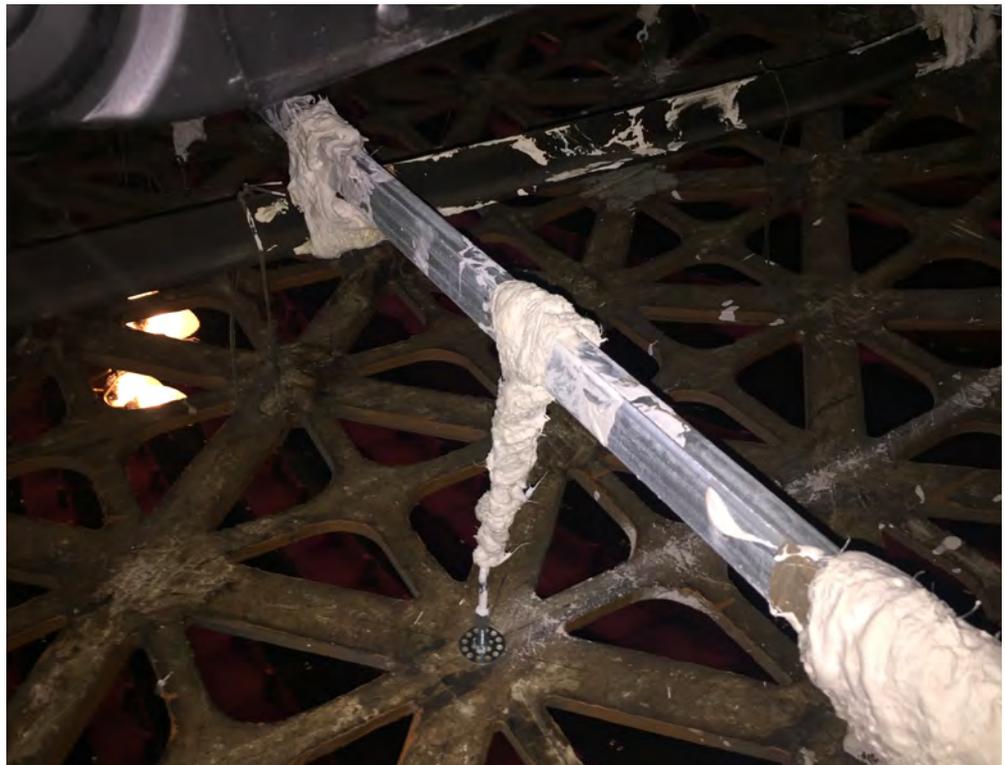
Figure 33: Fibrous plaster fretwork, given supplementary support with a new beam and wire-reinforced wads. This is a standard method of improving the stability of suspended ceilings.
